Section: 501-05

Model: 2000.75 Galaxy, built up to 25.08.2001 inclusive (build code 1G)

Subject: Central stowage compartment in the instrument panel difficult or impossible to open

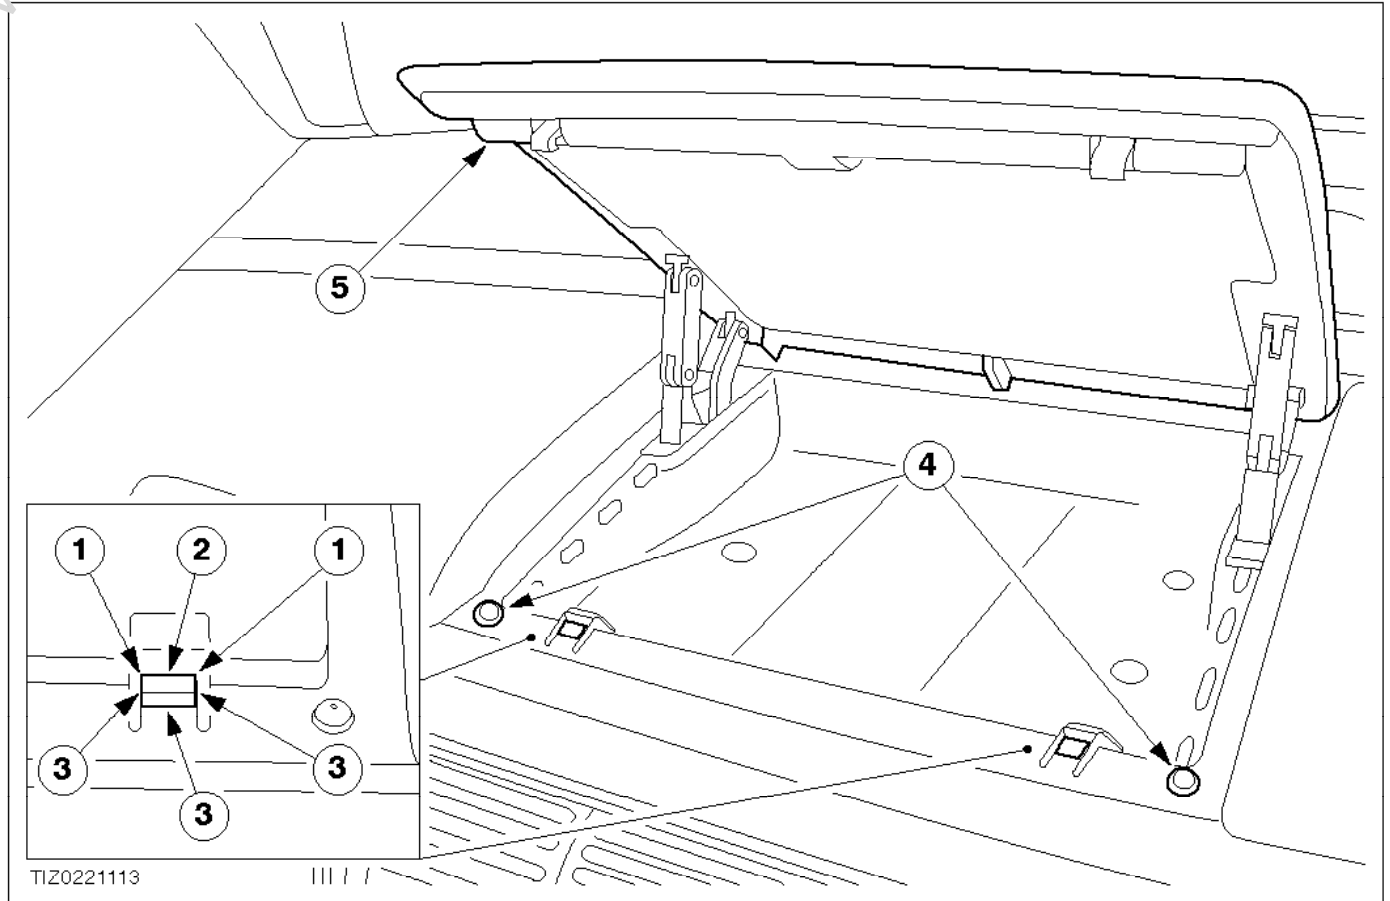
TIZ0221113

The following illustration shows the areas which could possibly be causing the cover of the central stowage compartment to be difficult or impossible to open. It is essential that the following steps are worked through in the correct sequence.

Item	Description
1	Burrs on the rectangular cutouts of the front latches
2	Burrs or deposits on the bar of the front latches
3	Burrs or deposits on the lateral guides of the front latches
4	Rubber stops
5	Cover for the central stowage compartment
