Section: 501-16

Model: Galaxy 2000.75 (Build Date: 08/2001 Onwards) (Build Code: 1G Onwards)

Subject: Front wiper blades touch left and right A-pillar when the windshield wipers are switched on

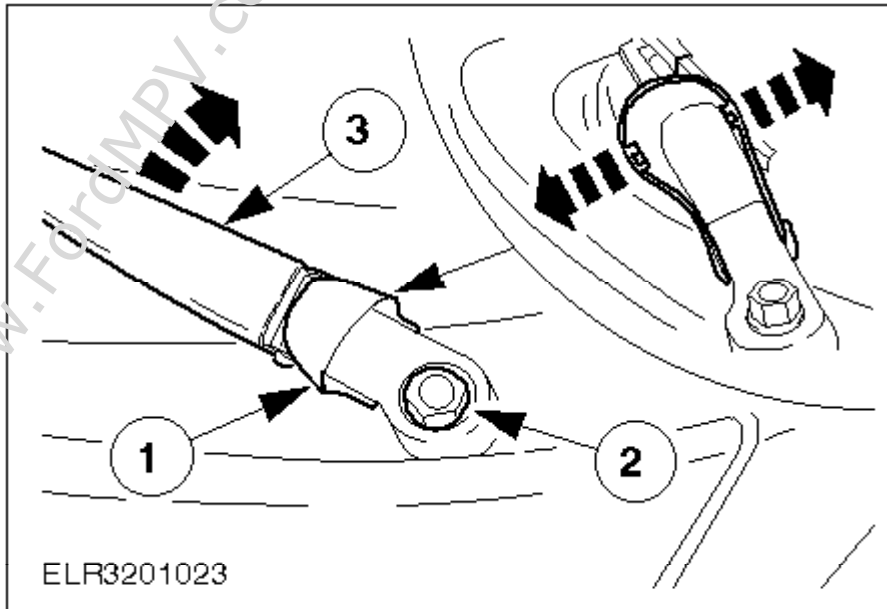
Should a customer express concern that the front wiper blades touch the A-pillar when the windshield wipers are switched on, the probable cause is that the windshield wiper arms are incorrectly positioned on the windshield wiper pivot shafts. To rectify the concern, the windshield wipers should be detached and installed in a different position.

1. Detach the windshield wiper arms.
 - 1 Pull the windshield wiper arm caps apart and fold them upwards.
 - 2 Undo the wiper arm nuts by about two turns.
 - 3 Fold the wiper arms up and release them from the tapers. Unscrew and remove the nuts.
