Section: 412-03

Model: Galaxy 2000.75, built up to and including 21.07.2002 (build code 2M)

Subject: Air conditioning system inoperative or inadequate cooling power; leaks in the air conditioning system

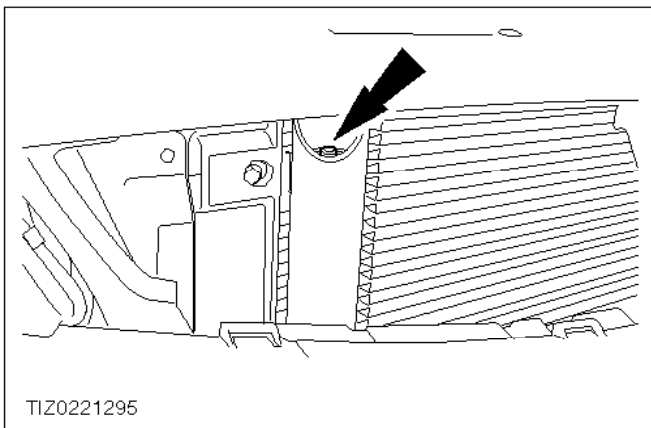
Should a customer express concern that the air conditioning system is inoperative or there is inadequate cooling power and there are leaks in the air conditioning system, the probable cause is a corroded/damaged aluminium cover on the air conditioning condenser or a damaged O-ring. To rectify this concern, a new air conditioning condenser should be installed.

4. Check the condenser for leaks.
 - Spray proprietary leak detecting spray into the opening and look for bubbles forming.
 - If bubbles are seen to form, install a new air conditioning condenser (see Parts Required).
For additional information, refer to 2000,75 Galaxy Workshop Manual Section 412-03A.
-
