**TECHNICAL SERVICE BULLETIN**No.24/2014  
09 May 2014

| <b>Subject/Concern:</b> Tray in overhead console stays open | |
| Galaxy 2006.5 (03/2006-) | Build Date: 01.02.2006-12.12.2014<br>Build Code: 6Y-EG<br>Assembly Plant: Genk |

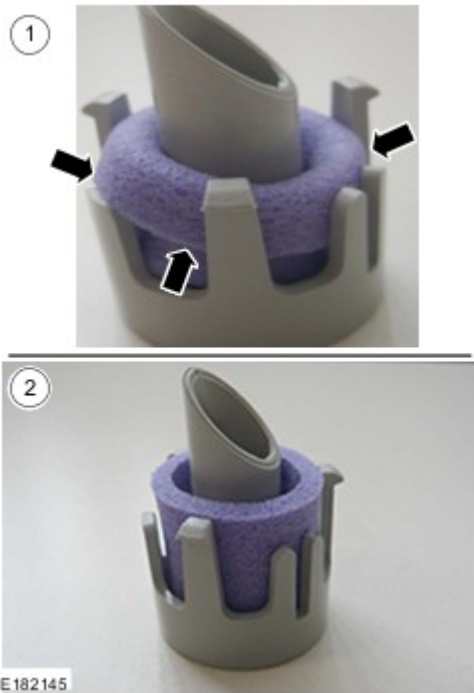
Should a customer express concern that the tray in the overhead console stays open, the probable cause is the spring foam folding itself inside the release button.

Example for damaged foam inside the release button

| Item | Description |
|---|---|
| 1 | Spring foam folded itself inside the release button |
| 2 | New service part |

The release button with foam is available for Galaxy 2006.5 as a spare part for servicing purposes. Do not replace the complete overhead console tray.
