## Rear Window Washer Repair Ford Galaxy

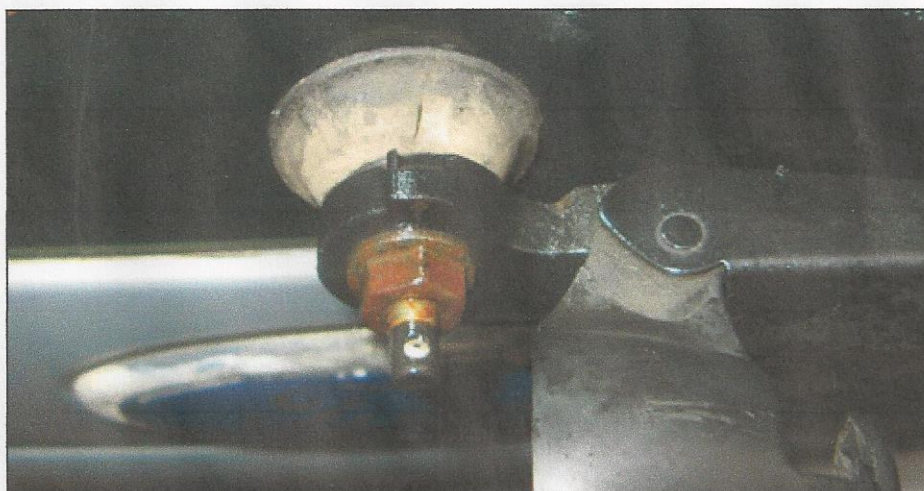
Cars of concern VAG is pure VW Sharan, SEAT Alhambra and FORD Galaxy have the second-generation rear window washer tube which passes through the axis of the rear window wiper (the wiper). Over time, the tube-axis drive inside dvornnika can oxidize, which causes that the tube, located inside her and which comes Washer zhitkost can jam and broke. As a result, liquid will flow in the opposite direction under the rear side door trim. Washer fluid may enter the control unit rear wiper and disable the electronics unit. The first sign that your windshield wiper problem is rotating together with the janitor pressure washer. So the handset is already broken and in need of repair.

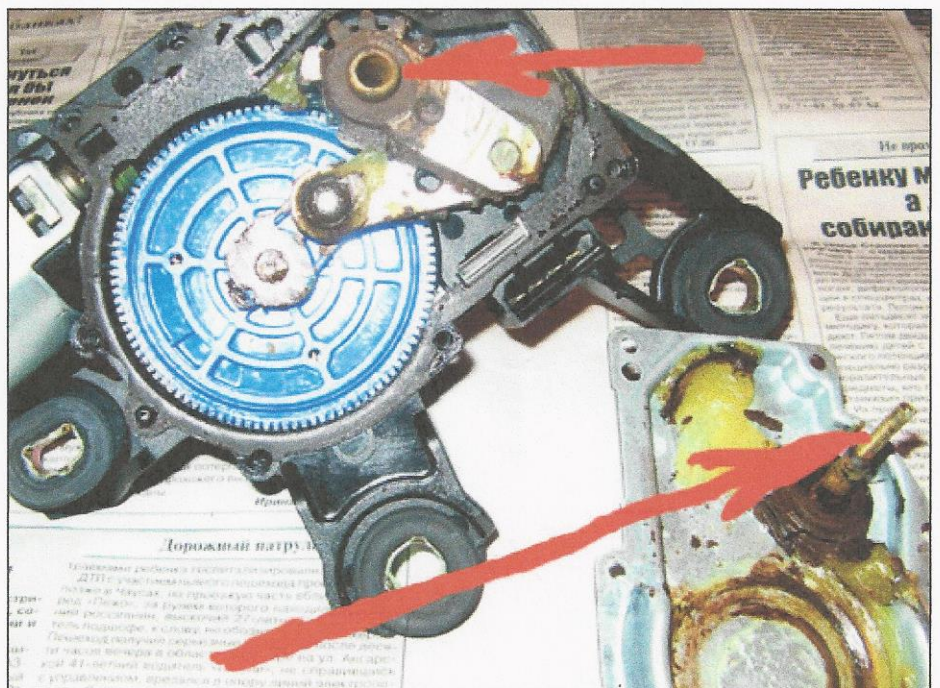
After removing the cover we see a broken pipe supplying water to the sprayer.
