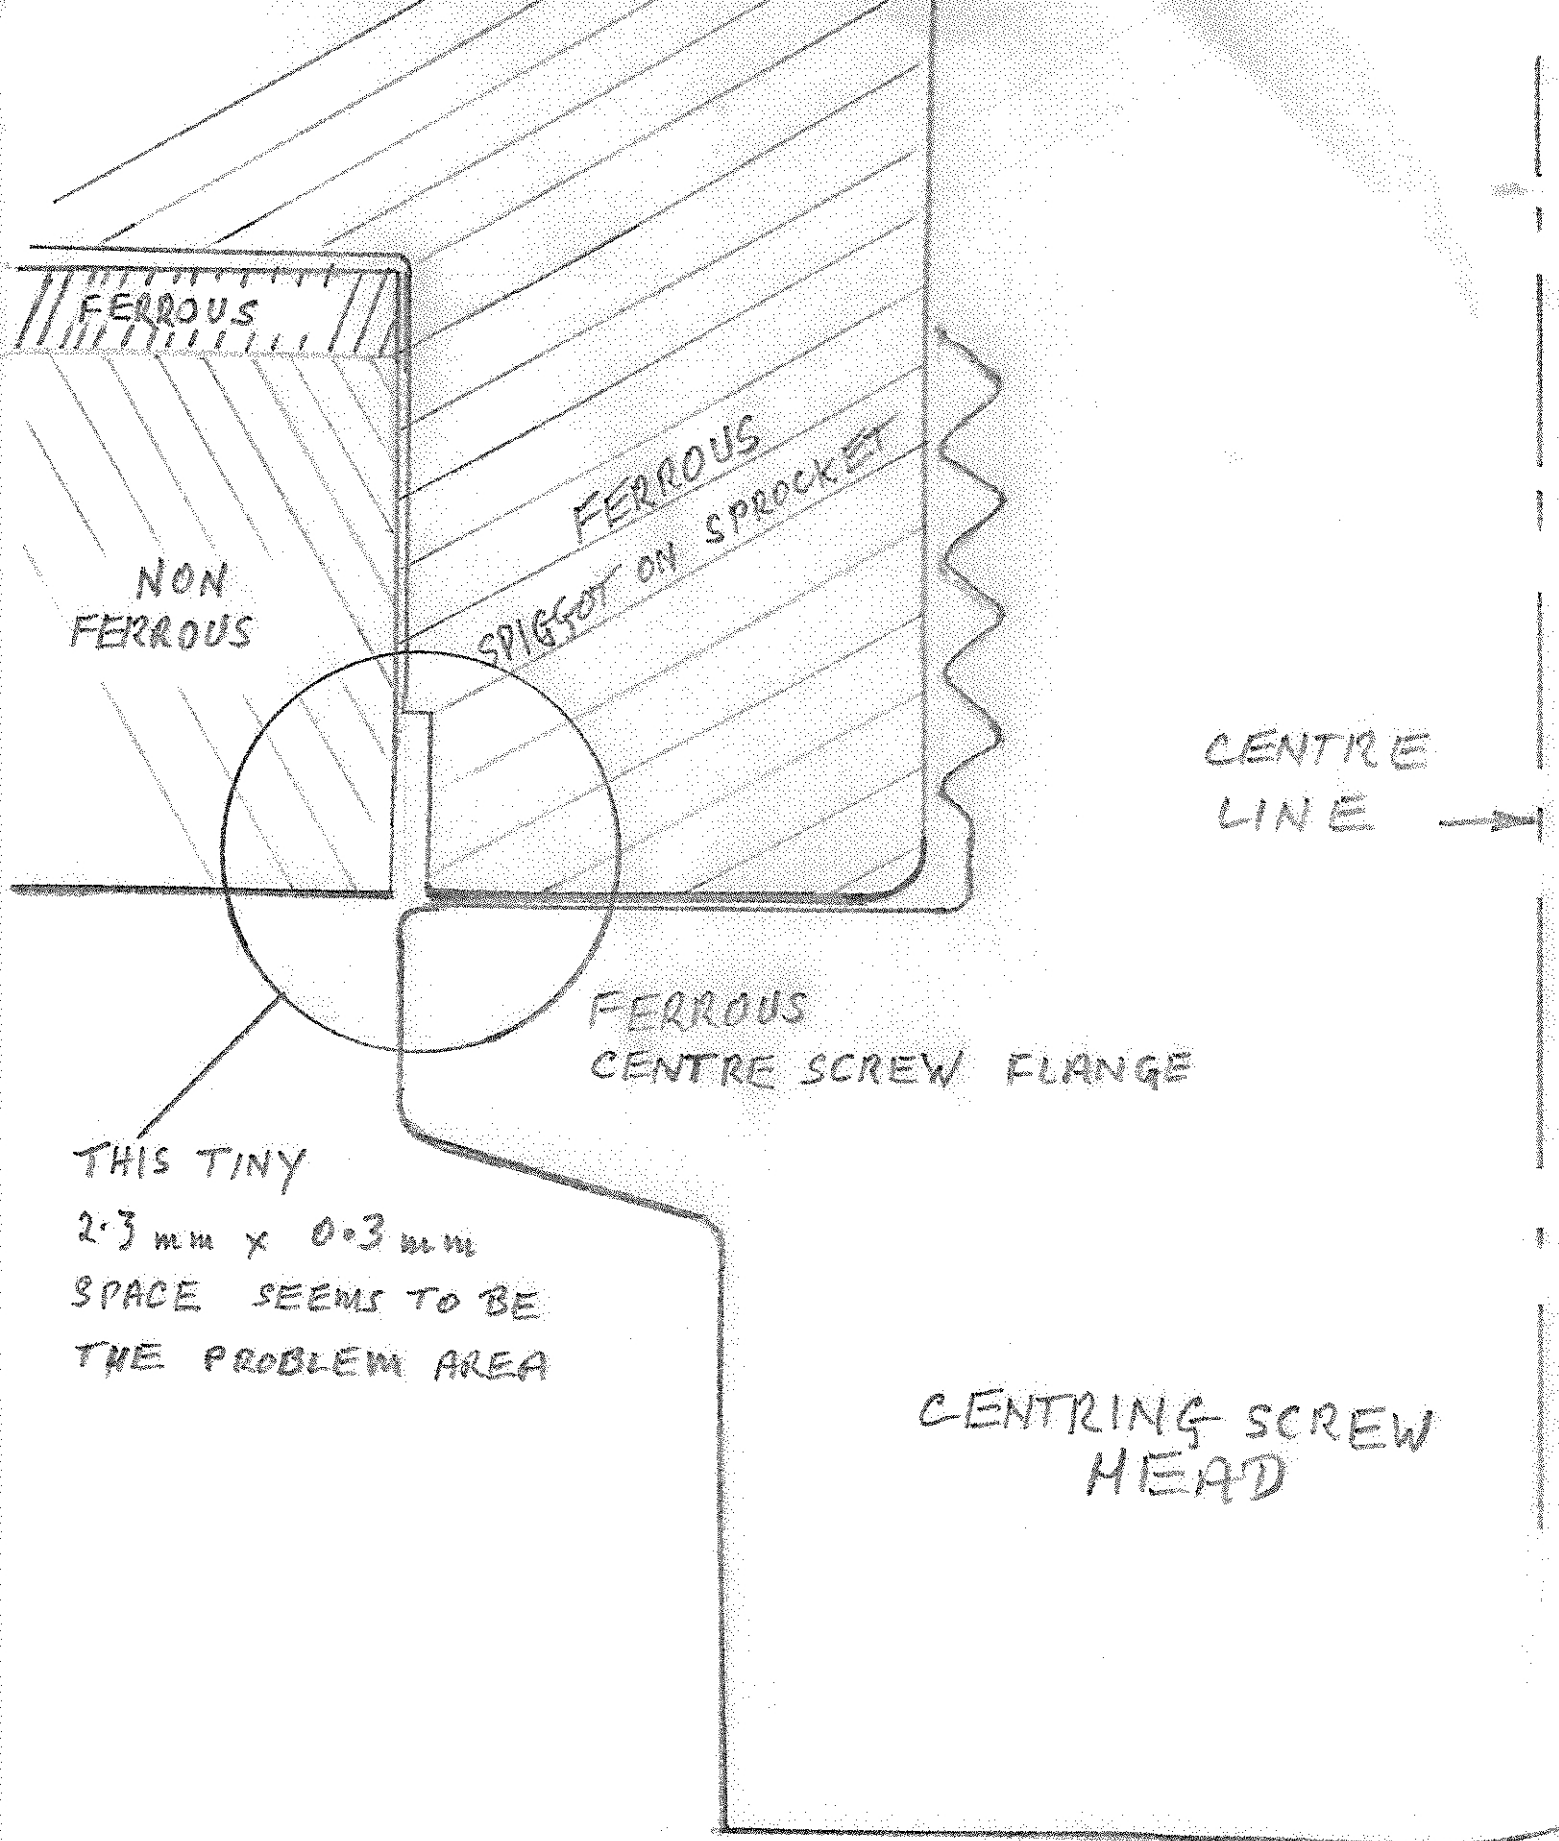
FERROUS

NON  
FERROUS

FERROUS  
SPIGGOT ON SPROCKET

CENTRE  
LINE →

FERROUS  
CENTRE SCREW FLANGE

THIS TINY  
2.3 mm x 0.3 mm  
SPACE SEEMS TO BE  
THE PROBLEM AREA

CENTRING SCREW  
HEAD
